Montour Falls Village Hall– Energy Action Plan

1 Introduction/Overview

1.1 Overview of the Municipality

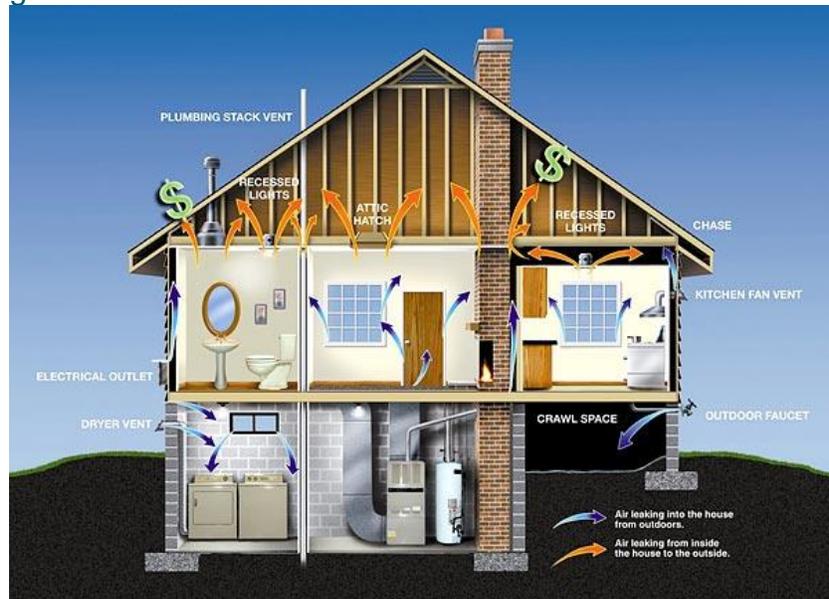
Figure 1: Sources of air leakage

The purpose of air sealing is to create an effective air tight seal on the building envelope. This will reduce the amount of air flow and heat loss from conditioned space to un-conditioned space or to the outdoors. Reducing air infiltration is vital to creating a more energy efficient building. Factors that cause high air flow rates include the size and number of openings that connect the conditioned and unconditioned spaces and pressure differences between the interior and exterior of the building. The differences in pressures are typically caused by stack effect, wind, and temperature differences between the inside and outside of the building.

This measure includes installing new weather stripping at exterior doors between the doors and door frames (approximately 72 linear ft), and new weather stripping for 27 operable windows (200 linear ft total for all windows except the ones in the courtroom and board room). It also includes caulking 100 ft of roof-wall joints on the second floor and parts of the first floor and caulking approximately 200 linear ft of the joints between window jambs and walls. An air sealing contractor will use special diagnostic tools to pinpoint and seal hidden air leaks

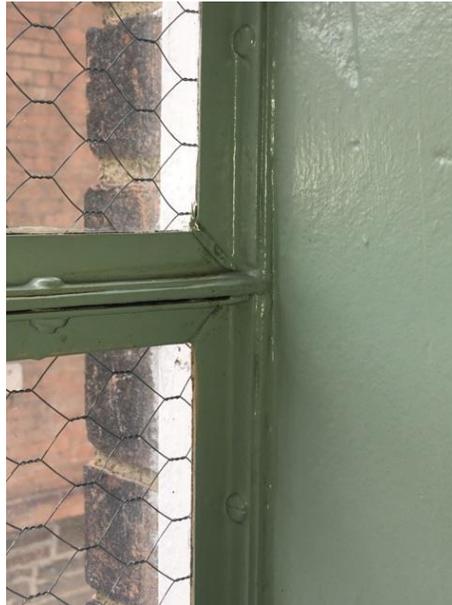
Figure 2: Single pane inoperable window in board room, painted shut

As mentioned in the building description, the auditor noted that two of the courtroom windows and all three board room windows are older single pane windows. The former also have cracked panes and gaps between the window jambs and walls. The board room windows are also single pane inoperable windows that are painted shut, but occupants have complained of very low temperatures in the room adjacent to the windows.

In addition, heat loss due to conduction through single pane windows can be very high. The five new replacement windows will utilize two panes of glass instead of one. The best option is to replace these windows with double pane single hung windows with an interior storm window and WindowSkins. WindowSkin is a transparent custom-fit window insulation system that mounts onto existing windows, upgrading energy efficiency and indoor comfort. It is an affordable window upgrade for the remaining 27 windows in the building too, as these already have storm windows.

- a. Replacing courtroom (2) and board room windows (3) with new double pane single hung windows with interior storm windows and WindowSkins.
- b. Window skins added to the remaining 27 single pane single hung windows in the building, which already have storm windows.

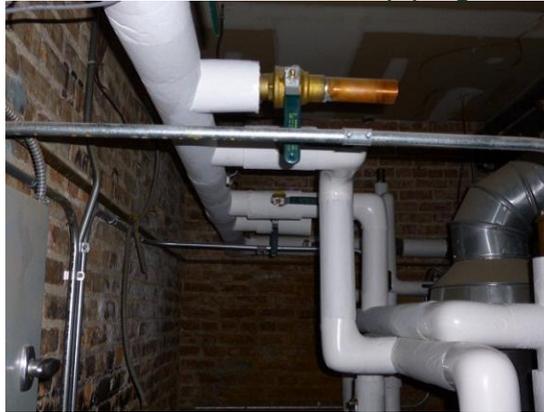
Figure 3: Fiberglass insulation with jacket for boiler and DHW piping

Heat is distributed from the boiler to baseboards in each zone by pipes containing hot water. These heating distribution system pipes lose heat to the surrounding space. If the heat is lost to an area that does not require heating, the drop in system efficiency can be significant. Uninsulated pipes in conditioned space may also overheat the space, wasting energy and causing comfort problems. All heating distribution system and DHW pipes located in unconditioned space should be insulated.

The boiler and the DHW system at the Village Hall are in the basement, which is unconditioned. The DHW copper piping, the boiler mains piping, zone pumps and PEX zone piping runs (to 8 zones) are in the basement and all the piping is uninsulated. We propose adding 1" of fiberglass insulation with jacket for the following:

- a. Steel boiler piping, 0.75" diameter: 25 ft
- b. Steel boiler piping mains, 3" diameter: 20 ft
- c. DHW copper piping, 0.5" diameter: 50 ft

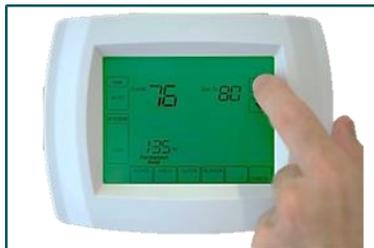
Figure 4: Programmable thermostat

However, the site contact stated that the occupants override the temperature manually and often forget to set it back. As a result, the room is heated to the occupied time setpoint even when it is not being used. The occupants change the thermostat settings frequently because 2 out of the 5 windows in this room are broken and loose, which causes cold air infiltration and a drop in the space temperature. Thus, even if the thermostat is set at 70 deg F, the actual temperature in the space is often closer to 65-67 deg F.

We propose installing a programmable thermostat which controls the hot water baseboards and sets back the temperature of this space to 65 deg F every day when the space is unoccupied.

Thus, the space temperature will be maintained at 68 deg F for 9 hours per day, from 8 AM to 5 PM and then set back to 65 deg F. At a price of \$59 for one thermostat, this measure will save 97 therms of natural gas annually, equivalent to \$77 in natural gas costs. The payback period for this measure is 9.6 months.

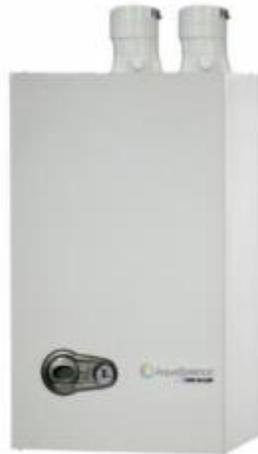
Figure 5: Proposed 100 MBH condensing boilers

The two existing forced air gas-fired boilers are 13 years old, are maintained regularly and work well. The site could install two condensing boilers to replace these, which would increase the combustion efficiency from the current 82.4% to approximately 92-95%.

From the occupancy and schedules obtained from the auditor and details about the building envelope for the existing condition, Taitem calculated the heating capacity of the boiler needed to provide enough heating to the building to be approximately equal to the existing capacity of 206 MBH.

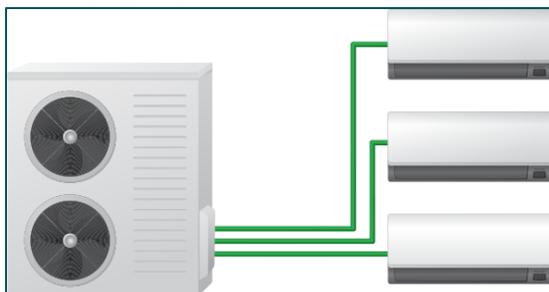
Figure 6: Proposed multi split heat pumps

Instead of installing new gas-fired boilers, the site can install ductless mini or multi-split Air Source Heat Pumps (ASHP) to heat and cool all the rooms on the first floor. Taitem assumed that the ASHP’s would be used in the cooling season as well, as the site uses 4 split AC units (each rated at 11,000 Btu/hr) during the cooling season on the first floor.

The ASHP would substantially lower the site's dependence on fossil fuel, as it could replace the natural gas boiler and all portable electric heaters, plus the older split systems that cool the first floor spaces. Along with ECM 2.10, this measure can completely remove the necessity to purchase natural gas.

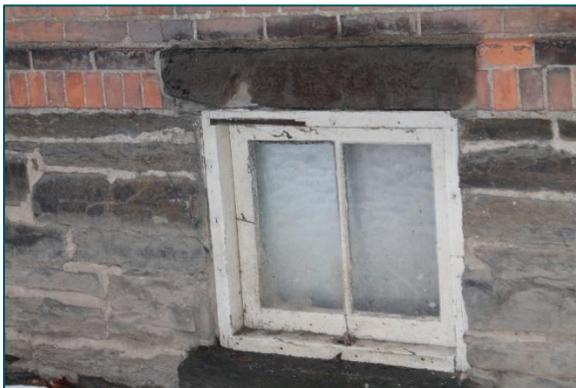
Figure 16: Basement window – boarded up, rigid board insulation

The basement walls are composed of stone and the basement ceiling is 3-4 ft above grade. The basement is unconditioned, and the windows are boarded up and insulated with 1" thick rigid board insulation with an R-value of 6.5. The auditor observed many areas in the basement where the old blown-in cellulose insulation of undetermined thickness had settled. The two gas-fired boilers, the gas-fired domestic hot water system and electric and gas meters are all located in the

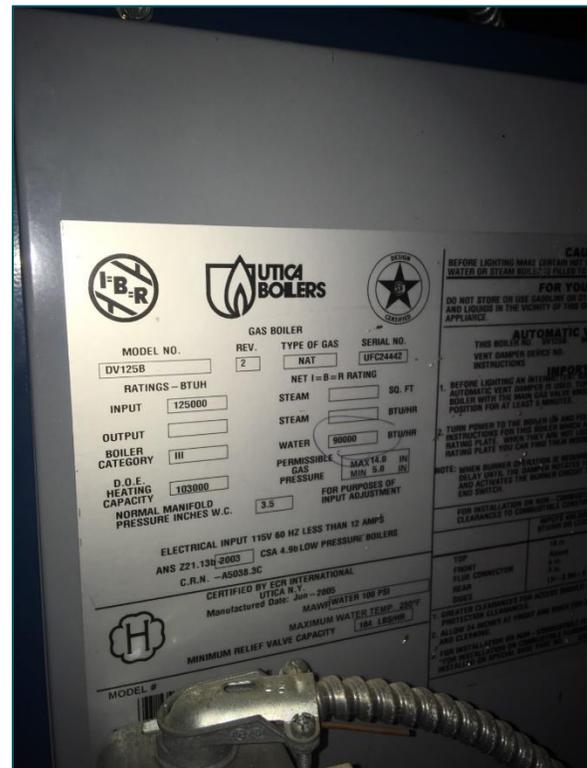
Figure 19: Existing hot water boilers

The natural gas boilers are 13 years old, function well and are regularly maintained. The site wants to conduct a cost-benefit analysis of replacing these boilers with Air Source Heat Pumps, as they are considering options for a Power Purchase Agreement with a solar developer. The domestic hot water demand at the site is low, as there are no showers. The existing DHW system is a natural-gas fired storage tank system.

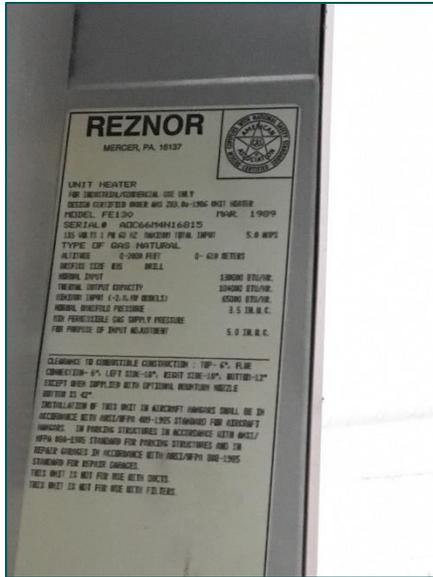
Figure 26: Second Reznor unit on 2nd floor

This measure consists of installing multi split system to replace the Reznor gas-fired units and the split air conditioning systems that served the second floor community theater. There are two ceiling mount Reznor gas fired heaters (rated at 132,000 Btu/h and 104,000 Btu/h) in the space and two split AC units (each rated 30,000 Btu/h) that provide cooling. Both the heating and cooling systems have not been used or maintained since this room has been out of use.

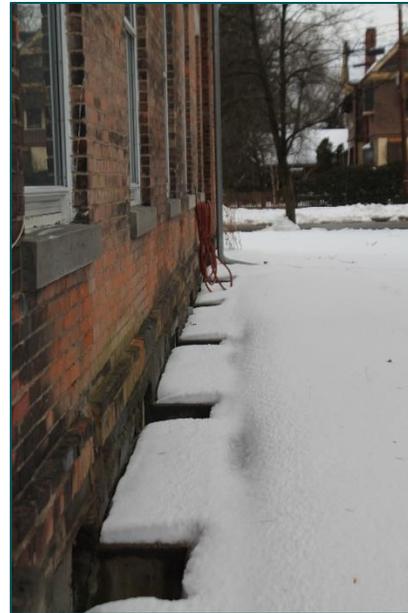
Figure 28: More water damage along West wall of building

From the auditor's photos of the site, Taitem observed that the North, West and East walls showed signs of water damage from either a roof leak or a break in the gutter pipe that runs along the perimeter of the building. This damage needs to be repaired by tuckpointing the bricks in the masonry wall, removing any parts of the wall frame that are rotting due to moisture and adding a fresh coat of paint where necessary. It is difficult to estimate from just photos how much damage has been caused to the walls, so Taitem used an estimate to calculate only the cost of tuckpointing bricks for the portions of the wall with visible signs of damage.

At a price of \$30,000 for repairing (only for tuckpointing bricks and excluding other steps) approximately 760 sqft of masonry walls, this measure won't result in direct energy savings, but it is a must before any air sealing measures are installed. It is imperative that the site hire a contractor to assess and repair water damage caused to the building and to locate the cause of moisture infiltration, as this directly affects the structural integrity of the building. The other recommended measures in Phase 1 should be installed only after this measure has been implemented.

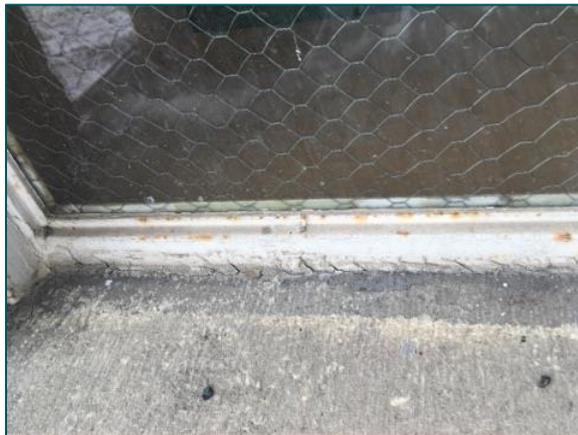
Figure 27: Gap between board room window and window frame

The building has 32 windows, and the auditor observed multiple windows with cracks and gaps between the frame and the wall. In addition, old weather stripping on the windows and doors had fallen apart, leaving gaps between windows and the walls, and between the doors and their frame. Thus, there were numerous sources of infiltration. Even though the building is segmented and zoned well, the courtroom is one of the largest spaces in the building, has two exterior walls, and 2 out of its 5 windows have broken panes. The courtroom thermostat is rarely setback when the room is unoccupied. This causes the spaces to be heated to the respective setpoint even when they are unoccupied. The board room has single pane inoperable windows that are painted shut. Though there are no cracks in the window panes, the occupants experienced very low temperatures in this room, owing to the gaps between the window jambs and the wall. Three windows on the second floor were also reported to have broken panes.
